CONDITION SURVEY, LIBBY ARMY AIRFIELD FT. HUACHUCA, ARIZONA

April 1971

Conducted by U. S. Army Engineer Waterways Experiment Station, Vicksburg, Mississippi

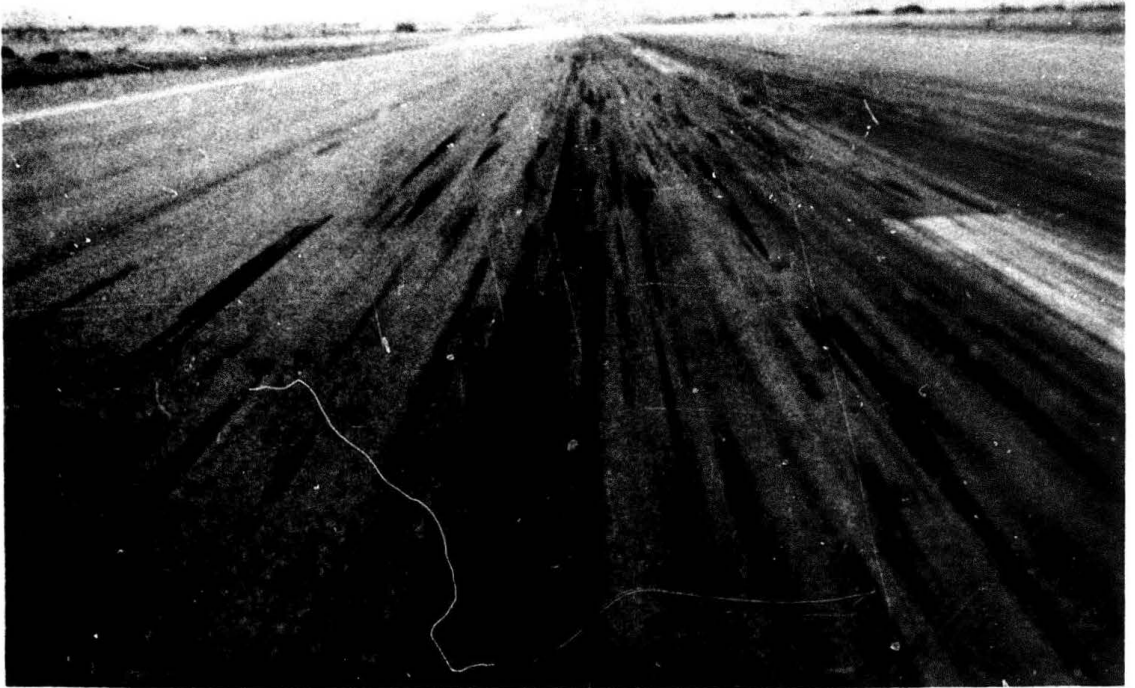
10. A visual inspection of the pavements in September 1970 indicated the pavement condition to range from poor to excellent. The sand seal placed on the primary runway in 1969 appeared to be in good condition on both the runway and shoulder areas (photographs 1-3). There was no evidence of any scuffing of the sand seal where aircraft had made 180-deg turns on the runway. There were two areas on the runway that contained birdbaths (photographs 2 and 4) and a depression from a drainage structure about midway of the runway. There was evidence of a few areas of longitudinal shrinkage cracking, but in general the runway condition was considered good. The surface of the crosswind runway, which was sand sealed in 1968, was considered to be in good

Photograph 1. View to northwest near southeast end of primary runway

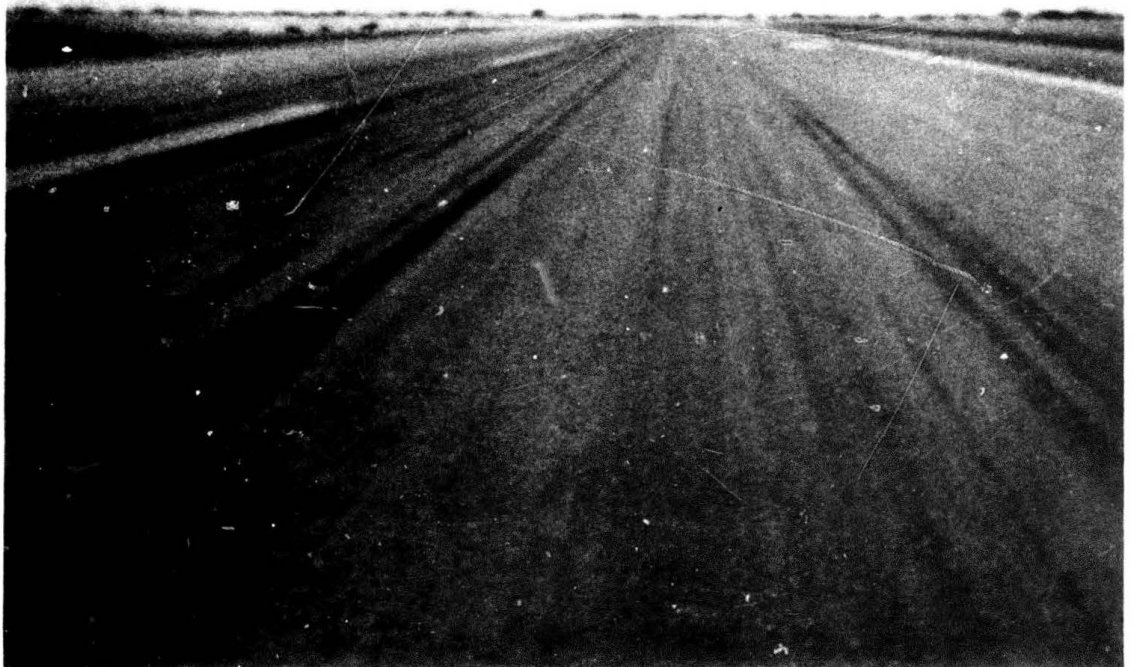
Photograph 2. View to northwest near center of primary runway. Note the
birdbath near right edge of runway

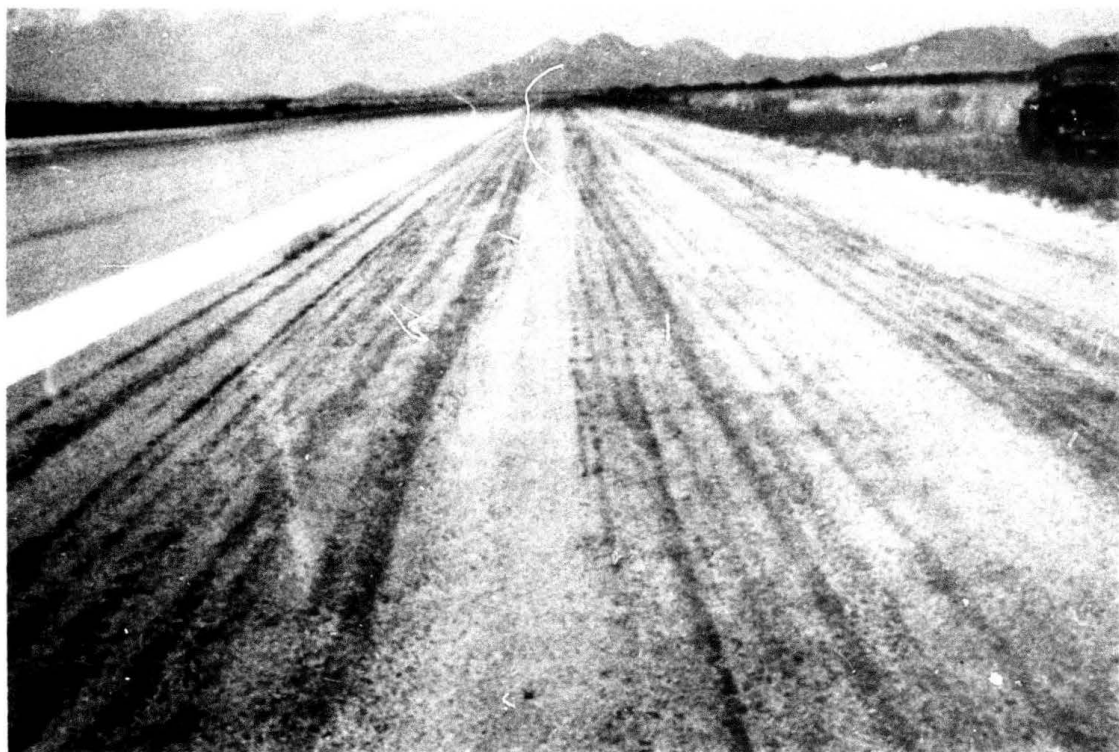
Photograph 3. Sand seal on surface of shoulder area along primary runway

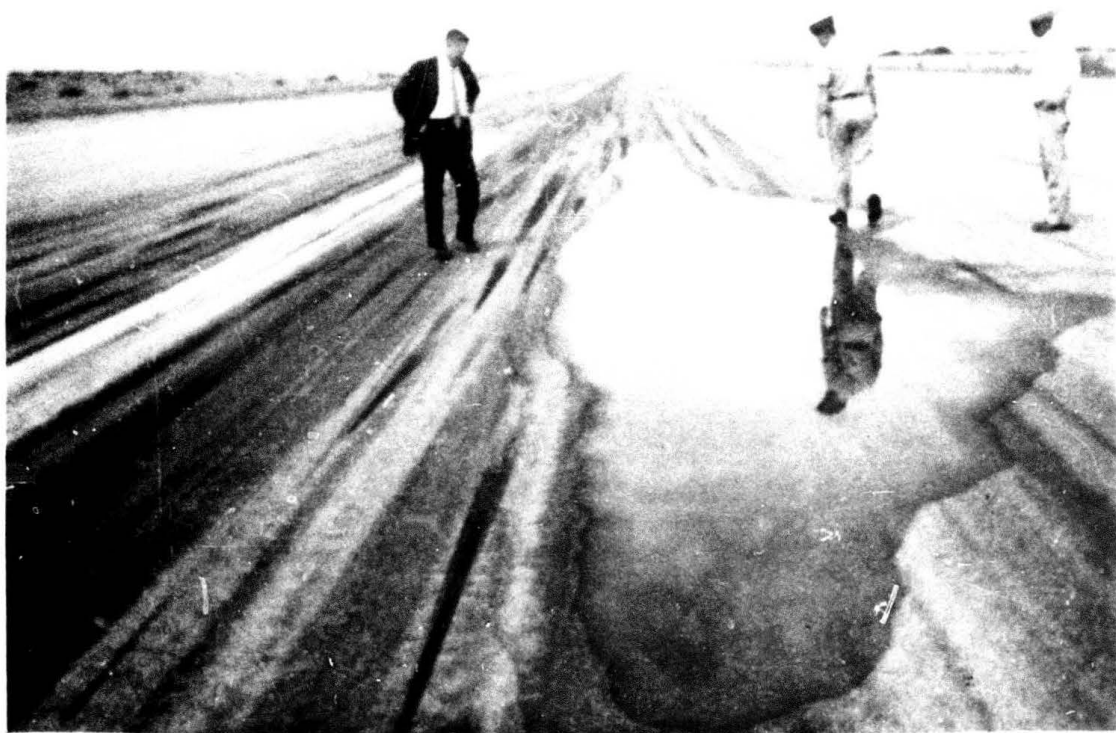
Photograph 4. Birdbath near southeast end of primary runway

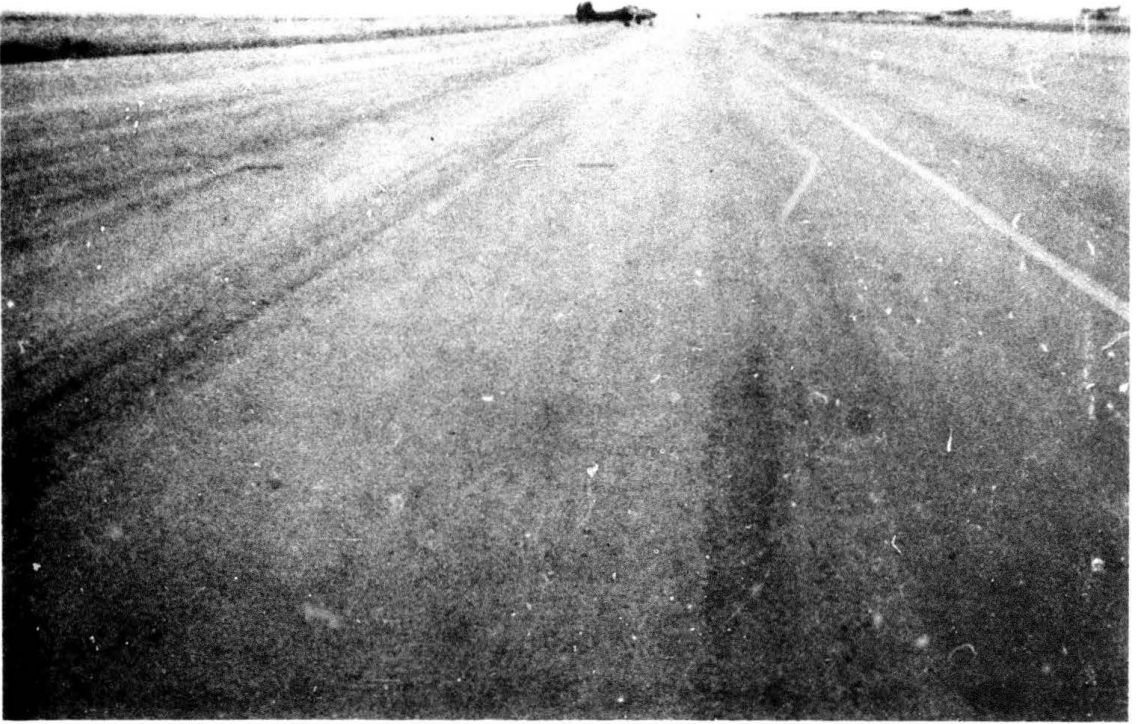
Photograph 5. Original E-W runway now used for aircraft parking

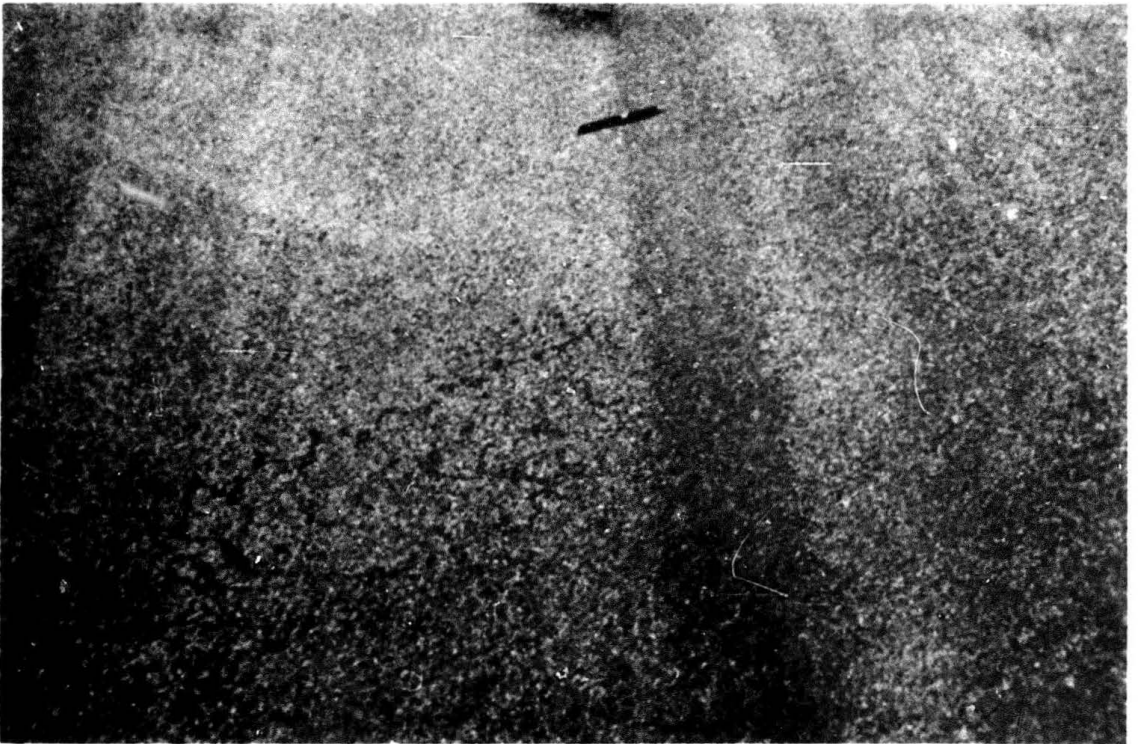
condition. The shoulders on this runway had not received a sand-seal treatment. The taxiway to the security area was sand sealed in 1968 and was in the same general condition as the crosswind runway. The portland cement concrete areas on the east and west connecting taxiways were in excellent condition. The portland cement concrete on the apron area was in poor condition. A considerable number of the slabs contained structural cracking from overload. The original E-W runway was in fair-to-poor condition (photograph 5). Evidence of distress in the form of cracking and deterioration of the pavement surface along the center line of the runway where aircraft taxi was observed. This area is used as a parking area when needed. Continued use will cause further distress in the pavement surface; however, the life of the pavement could be extended by moving the taxiing lane off the center line. The flexible pavement portion of the east connecting taxiway was sand sealed in 1969 and appeared to be in excellent condition (photograph 6).

Photograph 6. Condition of pavement surface on east connecting taxiway near intersection with primary runway
